# Manhole Inspection Summary

Manhole # S33GG\_009MH

**Inspection** ☐ Is Incomplete Rating: **5) Immediate Attention Required**

**Location** Address: **21 MARYLAND AVE**

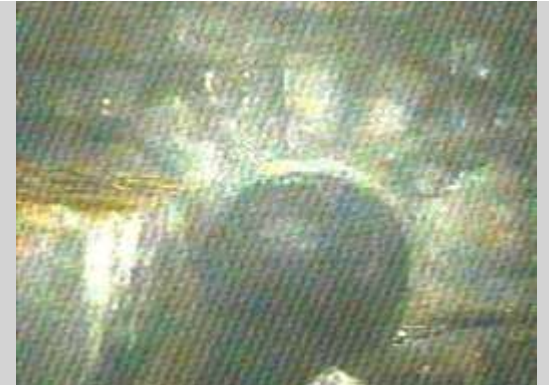
### 8 in. Circular Gravity Sewer Pipe Out @ 12 O'Clock

Rod and Bar (Angled)

Infiltration: **None** Pipe Seal Cond: **Unknown**
